## LEVEL 1 INSPECTION AND TESTING

### Dam Infilling Lot 17 Overlander Avenue Chatsworth

**Report for Roberts Brothers Pty Ltd  
Report No. 17297-001-Rev0  
13 September 2017**

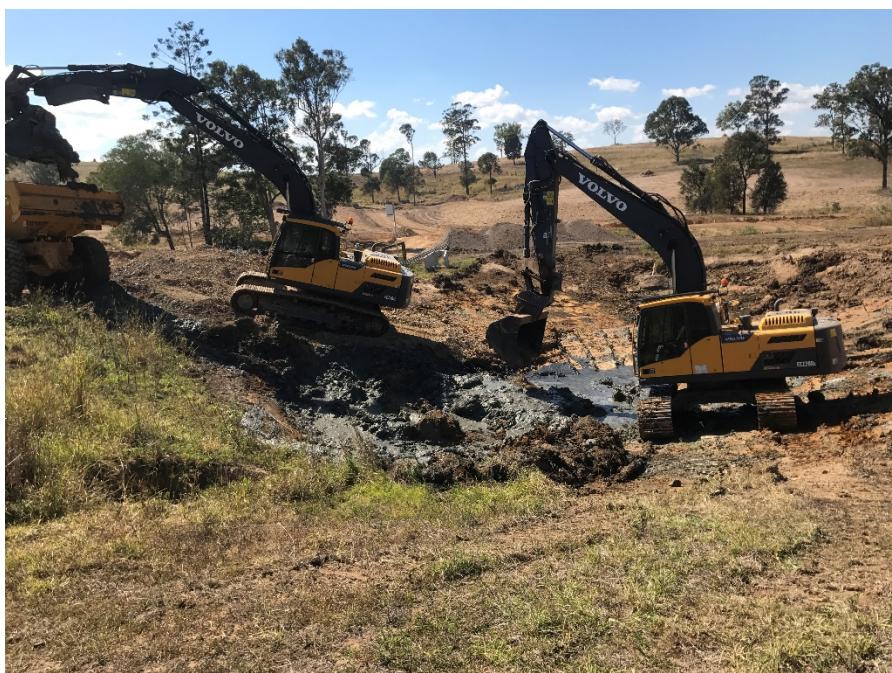
Wet, very soft silt was excavated from the dam to expose natural stiff to very stiff gravelly clay. Weathered rock was exposed in the subgrade in the western part of the dam.

*Text Figure 2: Mucking out wet, very soft silt from base of dam*

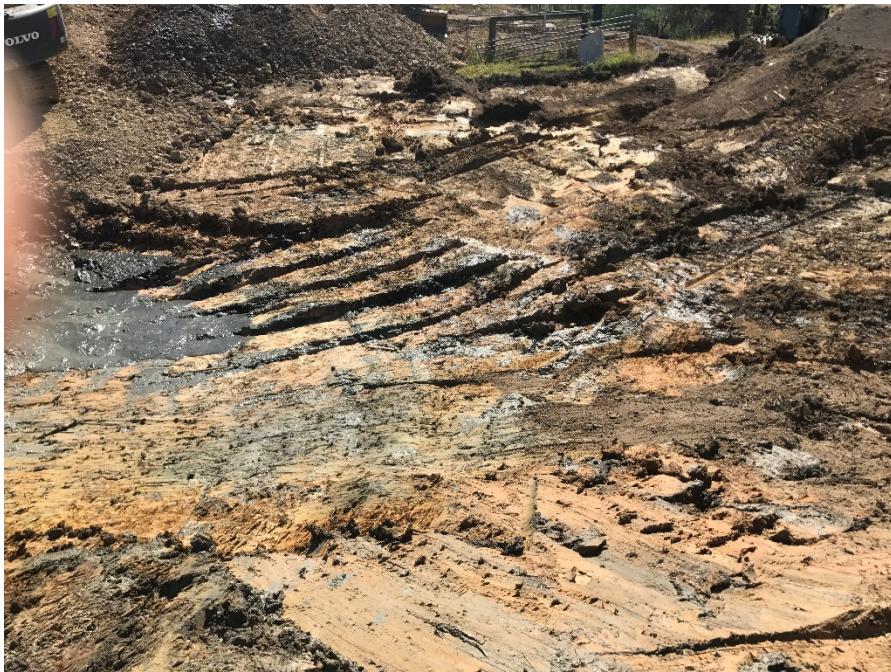
*Text Figure 3: Stiff clay at base of dam*

Prior to filling, the subgrade area was stripped of wet, very soft, organic material before being proof rolled to identify any soft spots. No significant soft spots were encountered, with the natural clay soils being in stiff (or stiffer) condition. Weathered rock was exposed in the western part of the dam. No groundwater seepage was observed in the subgrade.

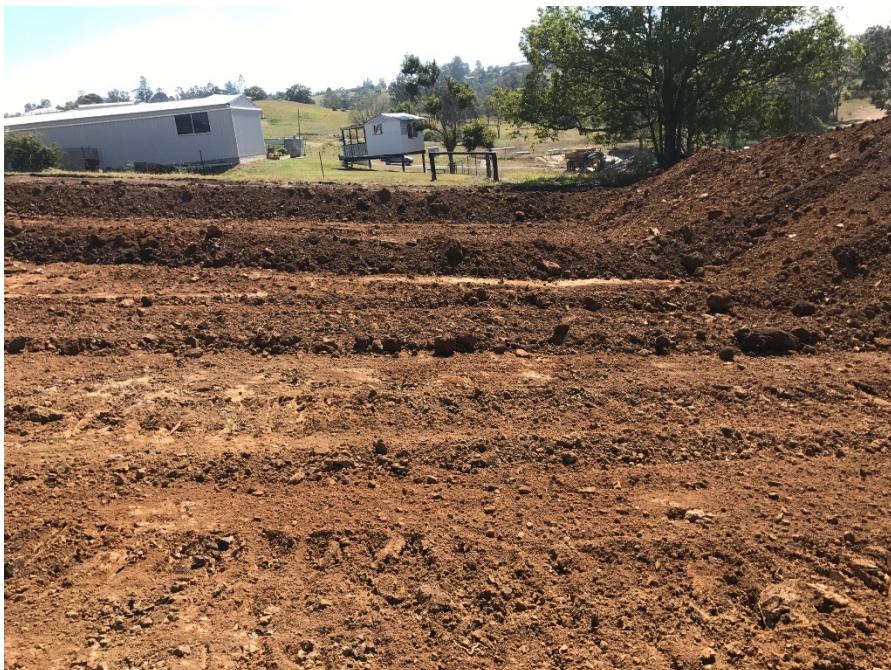
*Text Figure 4: Fill source at Lot 18*

Geotech conducted a total of 2 (No.) field and laboratory density tests on fill placed on 29 August 2017. Tests were located close to the middle of the dam area. Fill material (gravelly and sandy clays) was sourced from trimming of a ridge on Lot 18, located to the south of Lot 17.

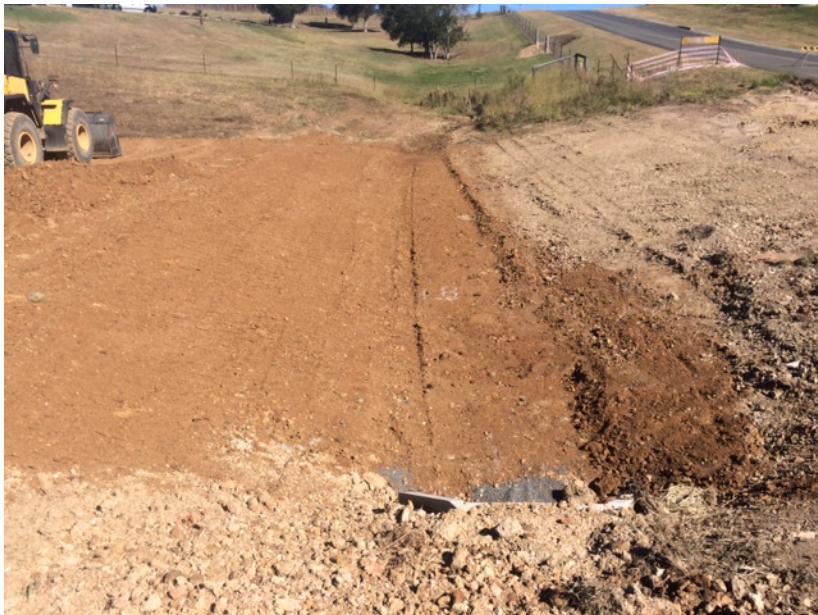
*Text Figure 5: Final fill shape (looking west)*

Fill was placed to a depth of approximately 1 m, with the final level shaped to maintain drainage. Roberts Brothers have indicated to us that approximately 500 m<sup>3</sup> of fill was placed within the dam.
