## LEVEL 1 INSPECTION AND TESTING

### Dam Infilling Lot 17 Overlander Avenue Chatsworth

**Report for Roberts Brothers Pty Ltd  
Report No. 17297-001-Rev0  
13 September 2017**

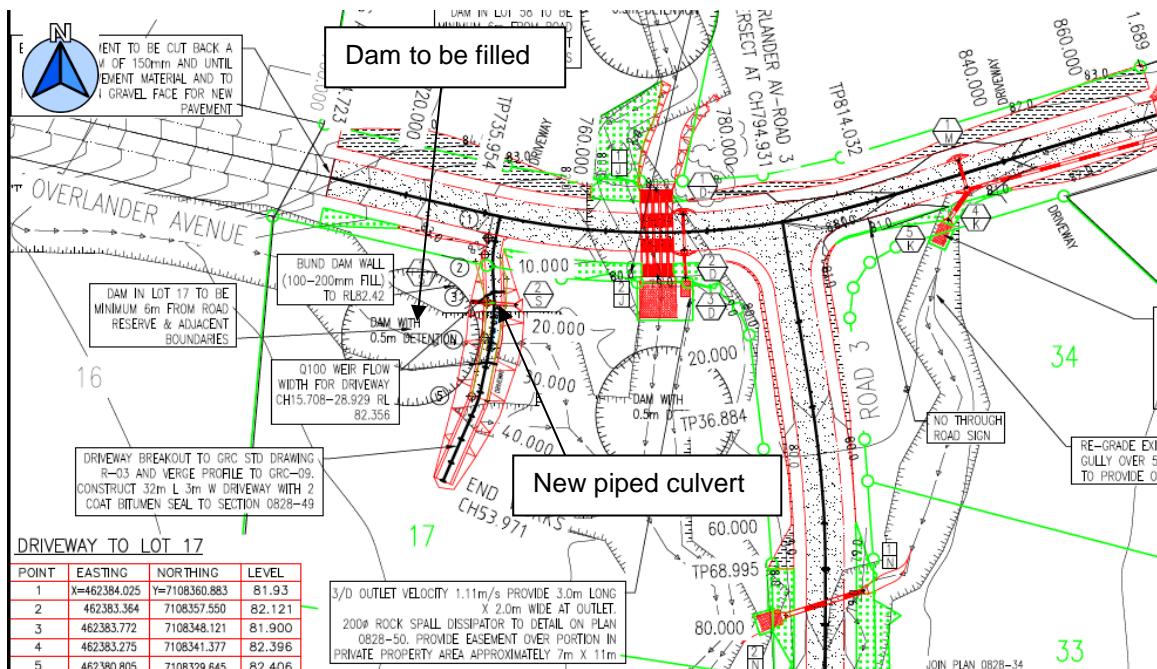
As shown in Text Figure 1 below, the dam that was filled was located near the north-west corner of Lot 17, within an existing shallow drainage channel.

*Text Figure 1: Dam location (courtesy Callaghan & Toth)*
