LEVEL 2 CERTIFICATION

24 Lots at Swagmans Ridge, and Cattlemans Court, Chatsworth Lots 63-85, 87 on SP328631

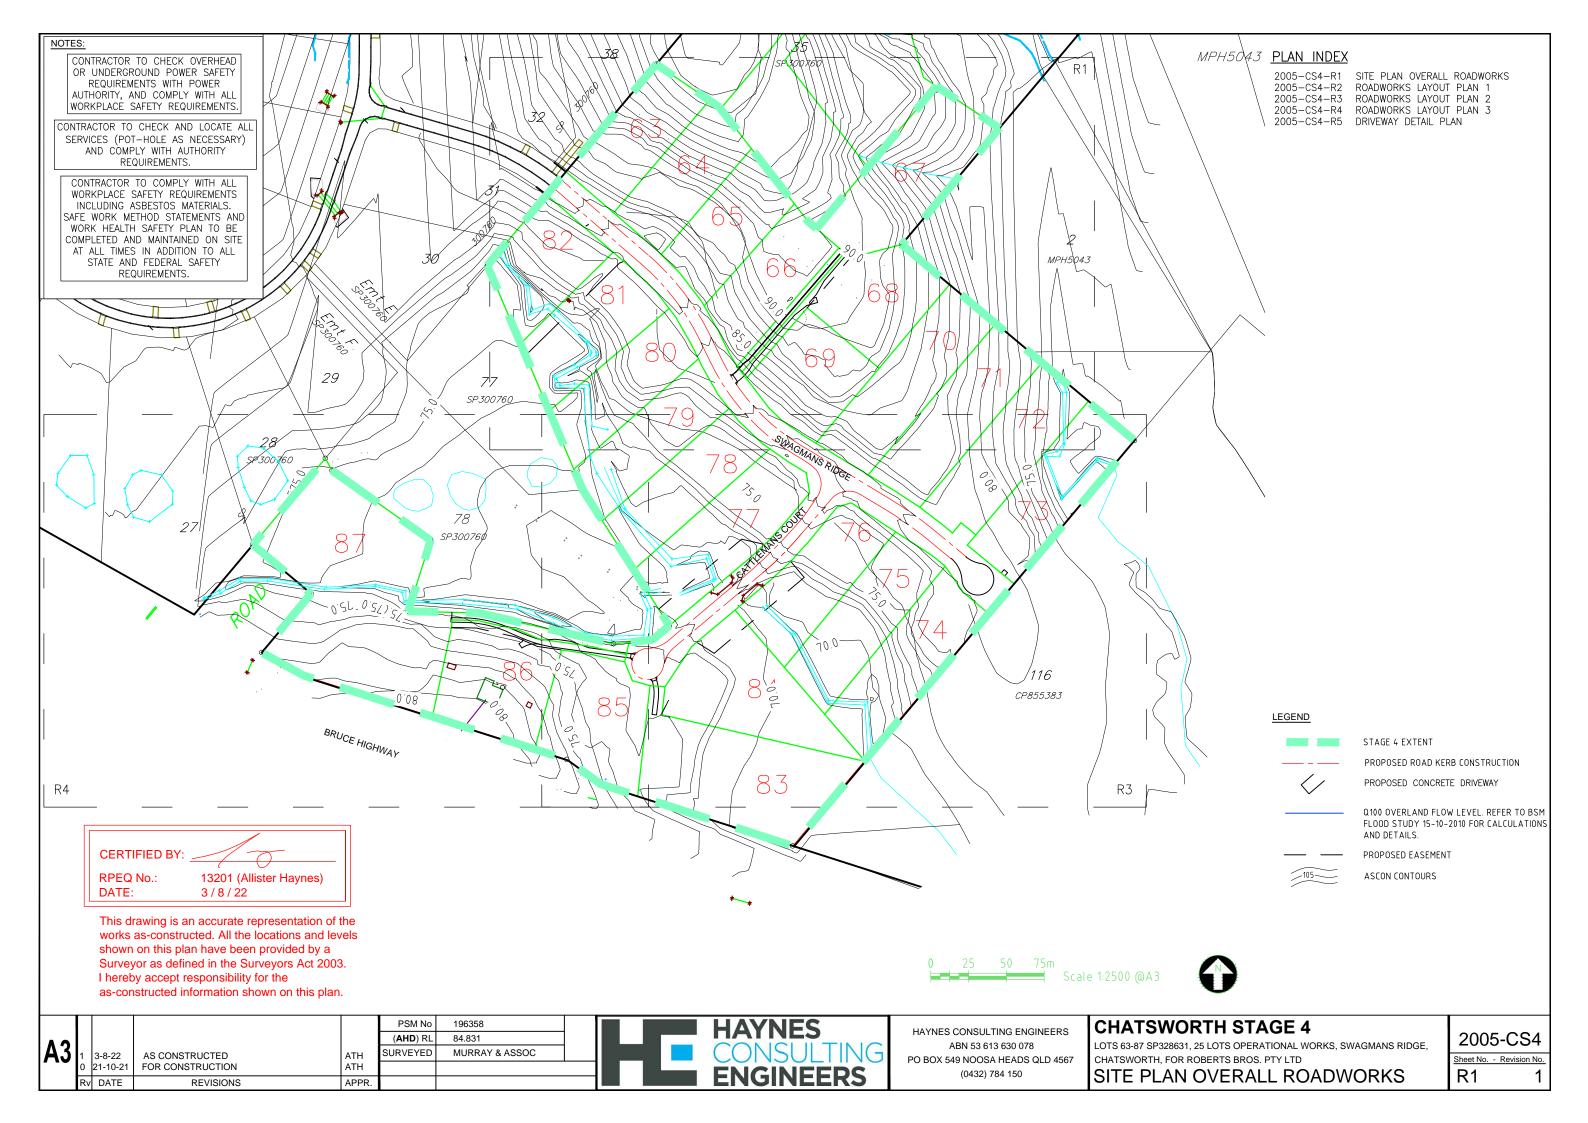
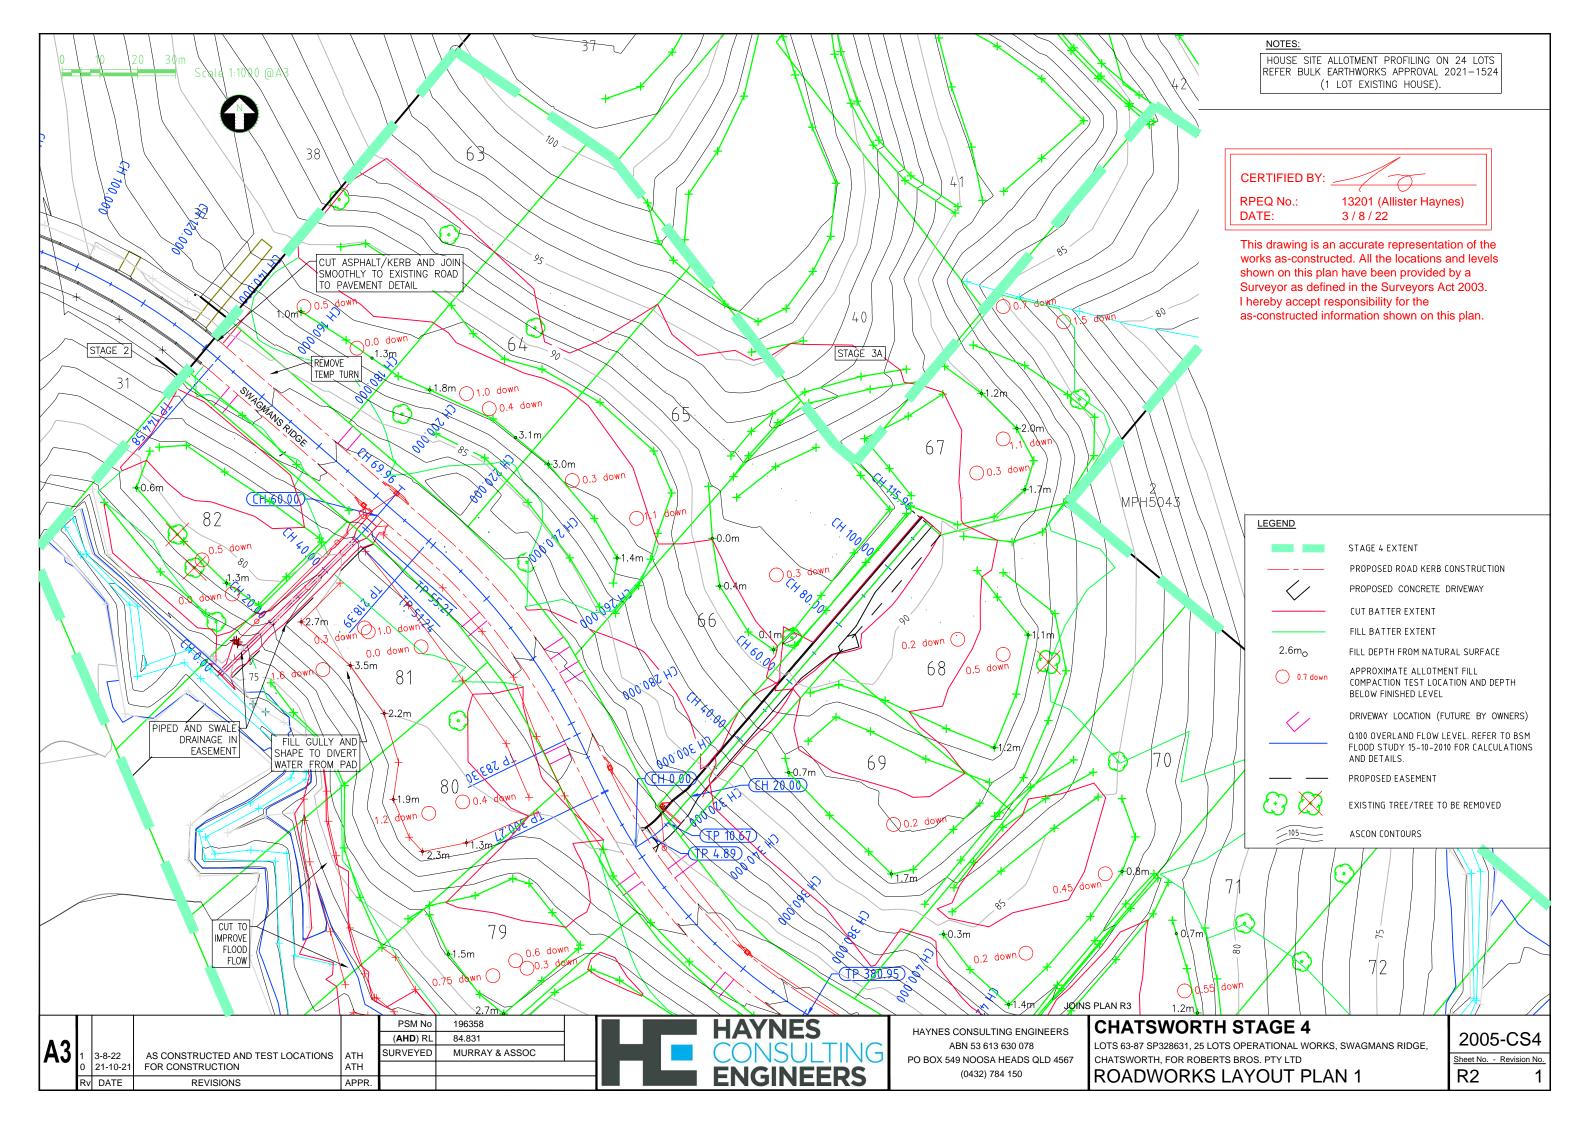
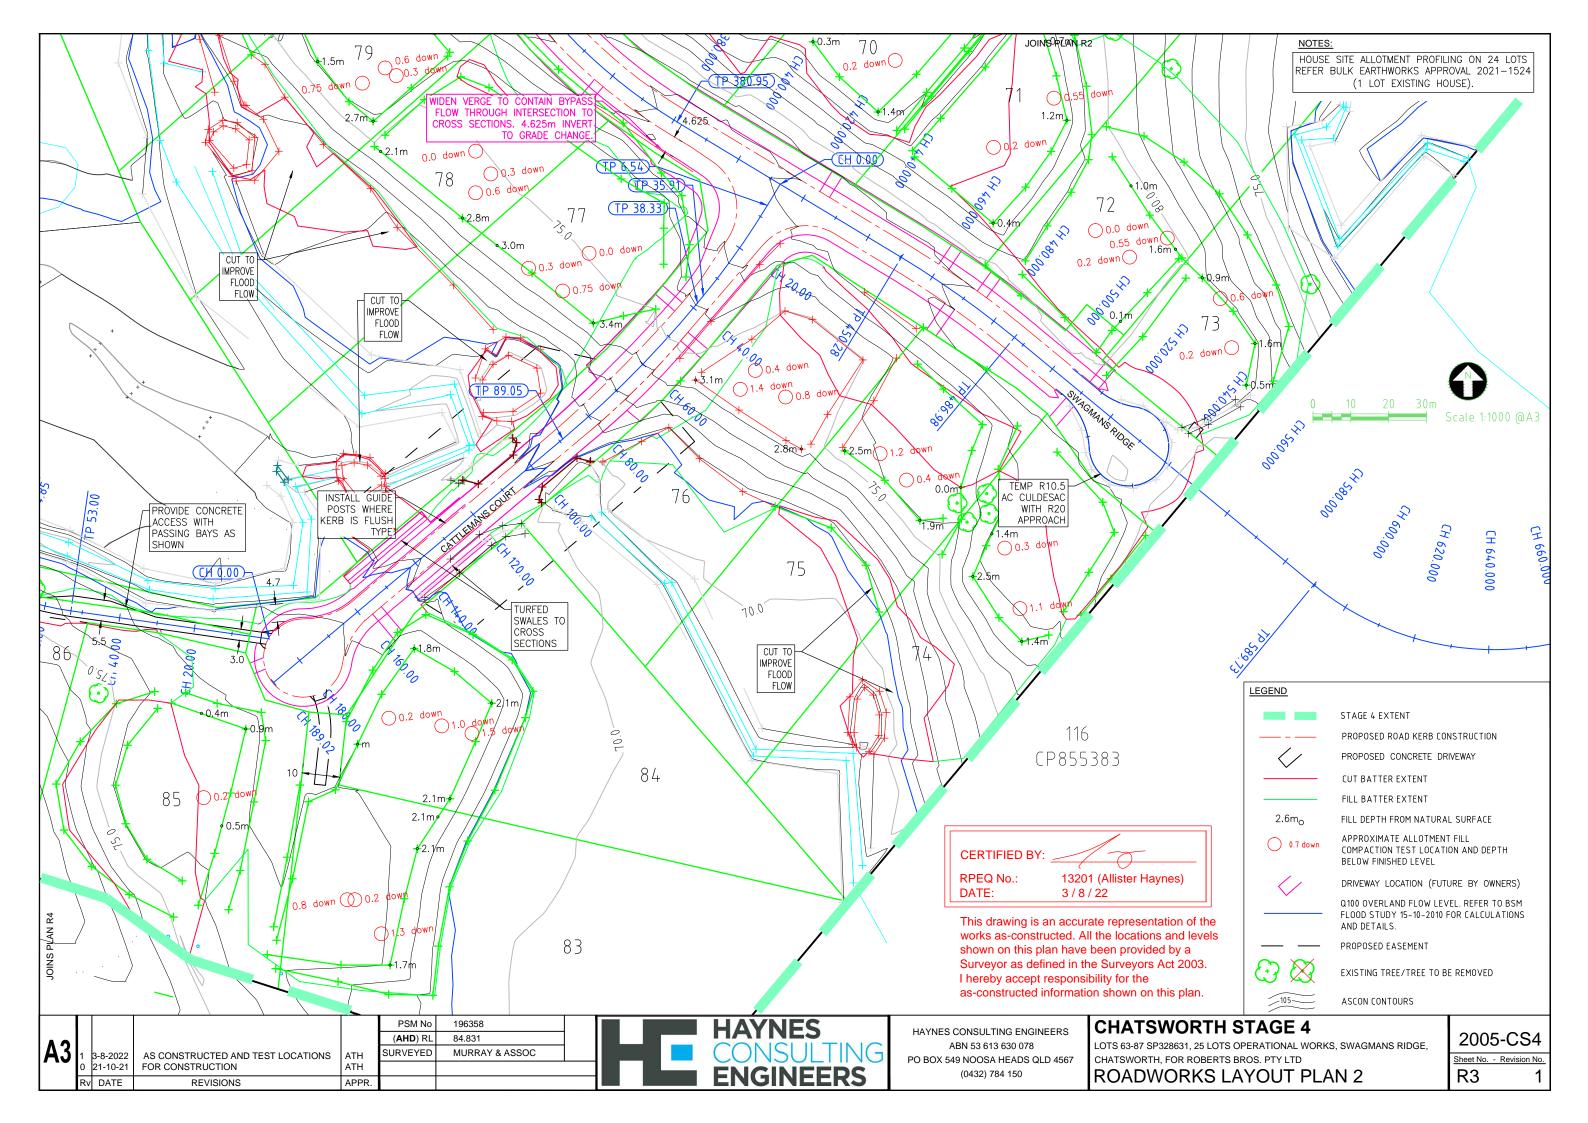
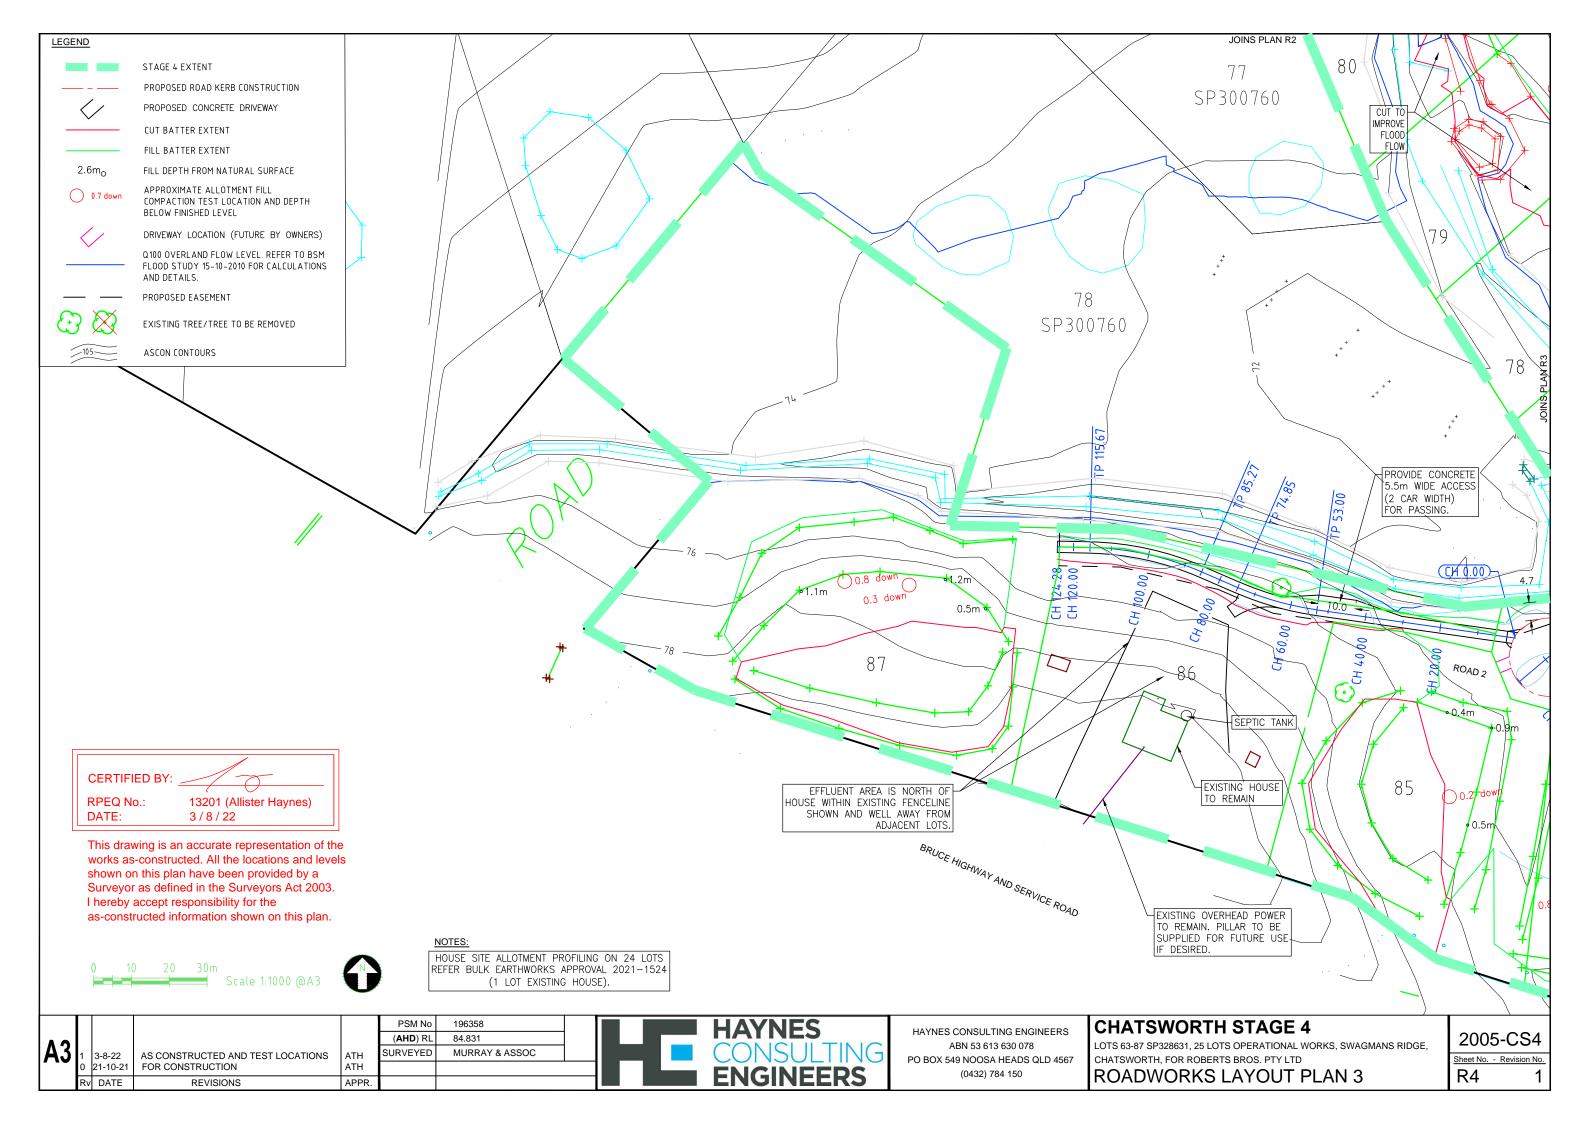
| CERTIFICATION LETTER | |
|--|--|
| TEST LOCATIONS PLANS 2005-CS4 SHEETS R1 TO R4 INCLUSIVE REVISION 1 | |

Determination of field density of compacted fill in accordance with AS1289 was completed by Douglas Partners Pty Ltd as attached. The compaction tests show that results were above the required 95% Standard Compaction. Test locations are shown on the attached plans 2005-CS3A sheet numbers R2-R4 inclusive Revision 1.
